Walkway Safety: Introduction to Slip, Trip, and Fall Risk Control

Report Number: [LB-30-10](#)

Release Date: [October 4, 2010](#)

Section Title: [Premises/Operations](#)

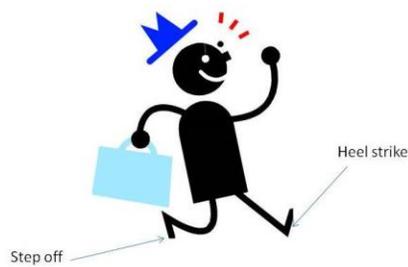
Figure 1. Gait Cycle of Walking Includes Heel Strike and Stepping Off

Why is it that a slip or trip only sometimes results in a fall or stumble? The answer lies in the biomechanics of walking (see Figure 1). Heel slips occur in early stance when weight is transferred to the lead leg. A heel slip results in forward acceleration of the weight-bearing leg, which results in a more unstable situation. Toe slips are considered less hazardous for a walker because of where they occur in the gait cycle. Toe slips take place in late stance as weight is being transferred to the forward leg. Even though weight is not evenly distributed, it is a more stable situation for the body and the walker may not lose his/her balance.

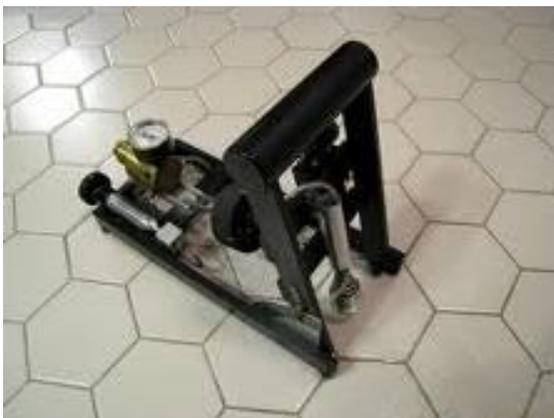
Figure 3. English XL Tribometer

- **The English XL:** The English XL was designed primarily for wet testing and is considered a Variable Incidence Tribometer (VIT) device. The angle and velocity of the leg-operating mechanism, and the size and shape of the test foot, were developed to replicate the heel strike of a human walking; the machine has a functional ankle. The leg of the XL VIT is free to accelerate once a slip occurs, as with a real-world human slip event.

Testing protocols, described in ASTM F1679, *Standard Test Method for Using a Variable Incidence Tribometer (VIT)*, are used by practitioners who own English XL units. The standard was officially withdrawn by ASTM on September 30, 2006 for failure to include an approved precision statement and for including reference to proprietary apparatus where alternatives exist. The 2004 version of the standard is still available for sale and is purchased by those who use the unit to perform slip resistance testing.

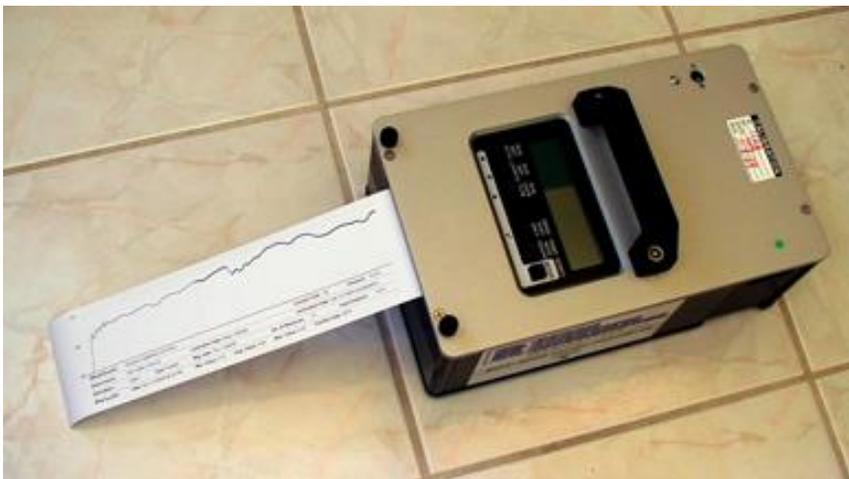
Figure 6. BOT-3000 Tribometer

- **BOT-3000:** The BOT-3000 (BOT is an acronym for Binary Output Tribometer) can measure both static and dynamic coefficient of floor friction on a variety of test sliders in both wet and dry conditions. The BOT-3000 provides a printed record of test parameters and results. The unit is available with sliders of different composition including Neolite. Dr. Jens Sebald of the University of Wuppertal (Germany) tested the BOT-3000 against traction of actual walking humans, with 72 test points including 12 surfaces, two different lubricants, and three shoe bottom materials. The correlation coefficient of 0.93 with the BOT-3000 proved excellent correlation. The testing results produced thorough and close correlation of measured human traction with any available tribometer. The National Floor Safety Institute (NFSI) recognizes the unit as capable of measuring wet static coefficient of friction (SCOF) within a defined range, and used with a reference calibration tile.
